**R-2933**

**July 6 1993**

**AXKT PHASE 3 FINAL REPORT**

**SIPPICAN, INC.**  
**7 BARNABAS ROAD**  
**MARION, MA 02738**

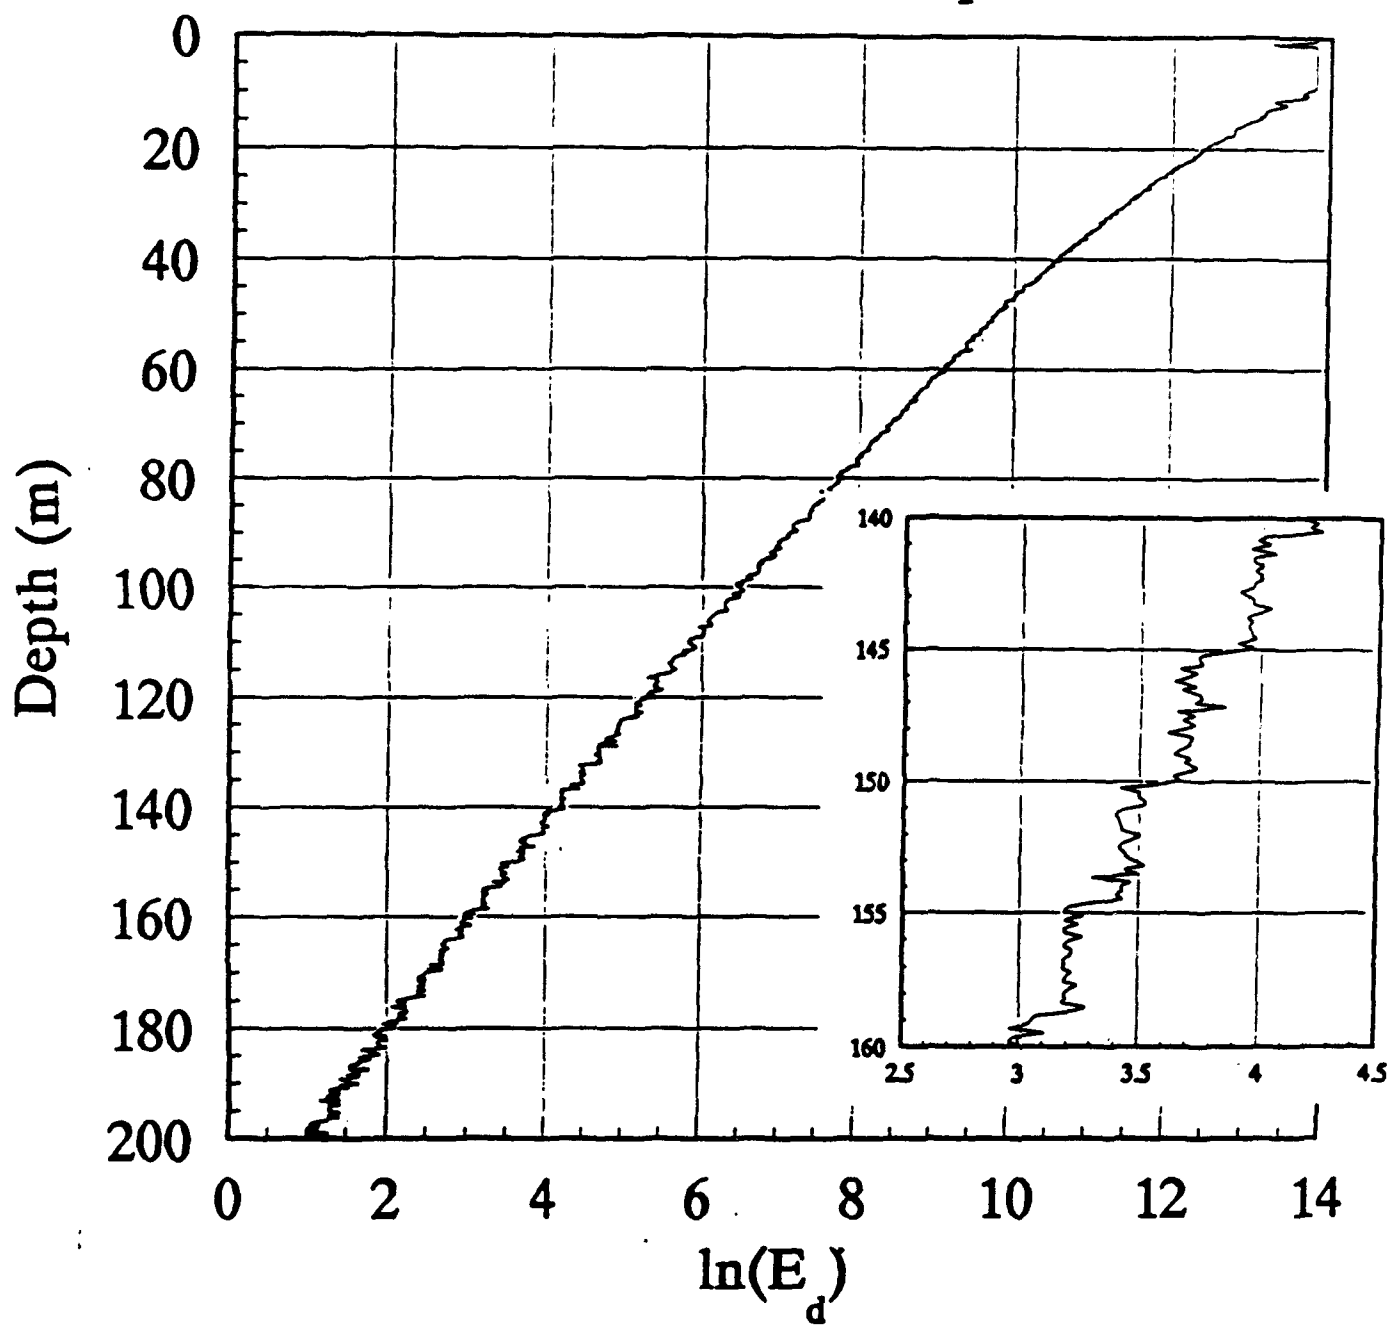
On data from three of the units, there appeared a granularity or quantization in the profile. This staircase phenomenon appears when certain conditions are met, i.e., the optical intensity is at a particular level (usually at a low illumination level) and the rate of attenuation with depth is relatively slow. When these conditions are met, the data will not correctly follow the illumination gradient smoothly, but will 'lock' onto a particular illumination level for a short length of time and then snap to a new light level and remain at this new level. This process repeats itself many times, thereby creating a trace that appears to have steps in what would normally be a smoothly changing illumination level. Graph 1 illustrates this effect. In the inset of the graph is an expanded view of the steps. As can be seen, these steps increase in severity as the light intensity decreases. The effect of these steps is to introduce a large amount of noise in the computed K value. In the extreme, the K is zero for a short depth where the step plateau is and the K is huge for the place where the step begins its transition. Currently the only way to deal with the steps is to filter the raw irradiance data and then calculate the K value from this data.

Several of the XKT units exhibited signal saturation at the surface just after probe release. This condition (See graph 1) causes an apparent constant level of optical illumination (a 'K' of zero) for a certain depth. This condition is almost certainly a result of mis-scaling the electronics in either the probe or the buoy as the actual detector has a considerable greater dynamic range than the electronics. There is no processing technique that will re-create this piece of data, it is completely lost. After a certain depth is reached, the water column will have attenuated the light to the point where the signal becomes 'on-scale' and will be processed. As the measurement for K is a differential measurement, the loss of this data does not effect the remaining data.

Several units that were deployed exhibited a condition of 'saturation' when the probe was still near the surface. Upon descending to a deeper depth, the units would then resume normal operation and provide a good data set (See graph 1).

The symptoms of this problem suggest that the problem lies in the electrical scaling of the probe's conditioning electronics and not due to the optics themselves. The electronics are scaled so as to nominally accept the brightest possible conditions (overhead sun, low latitudes) while still providing good low light level data. Due to normal manufacturing tolerances, this scale moves around to some degree. If the scale is not positioned so that these tolerances are taken care of, this limiting problem could arise. In this case the solution is to either tighten the manufacturing tolerances or to rescale the nominal values to accommodate these variations.

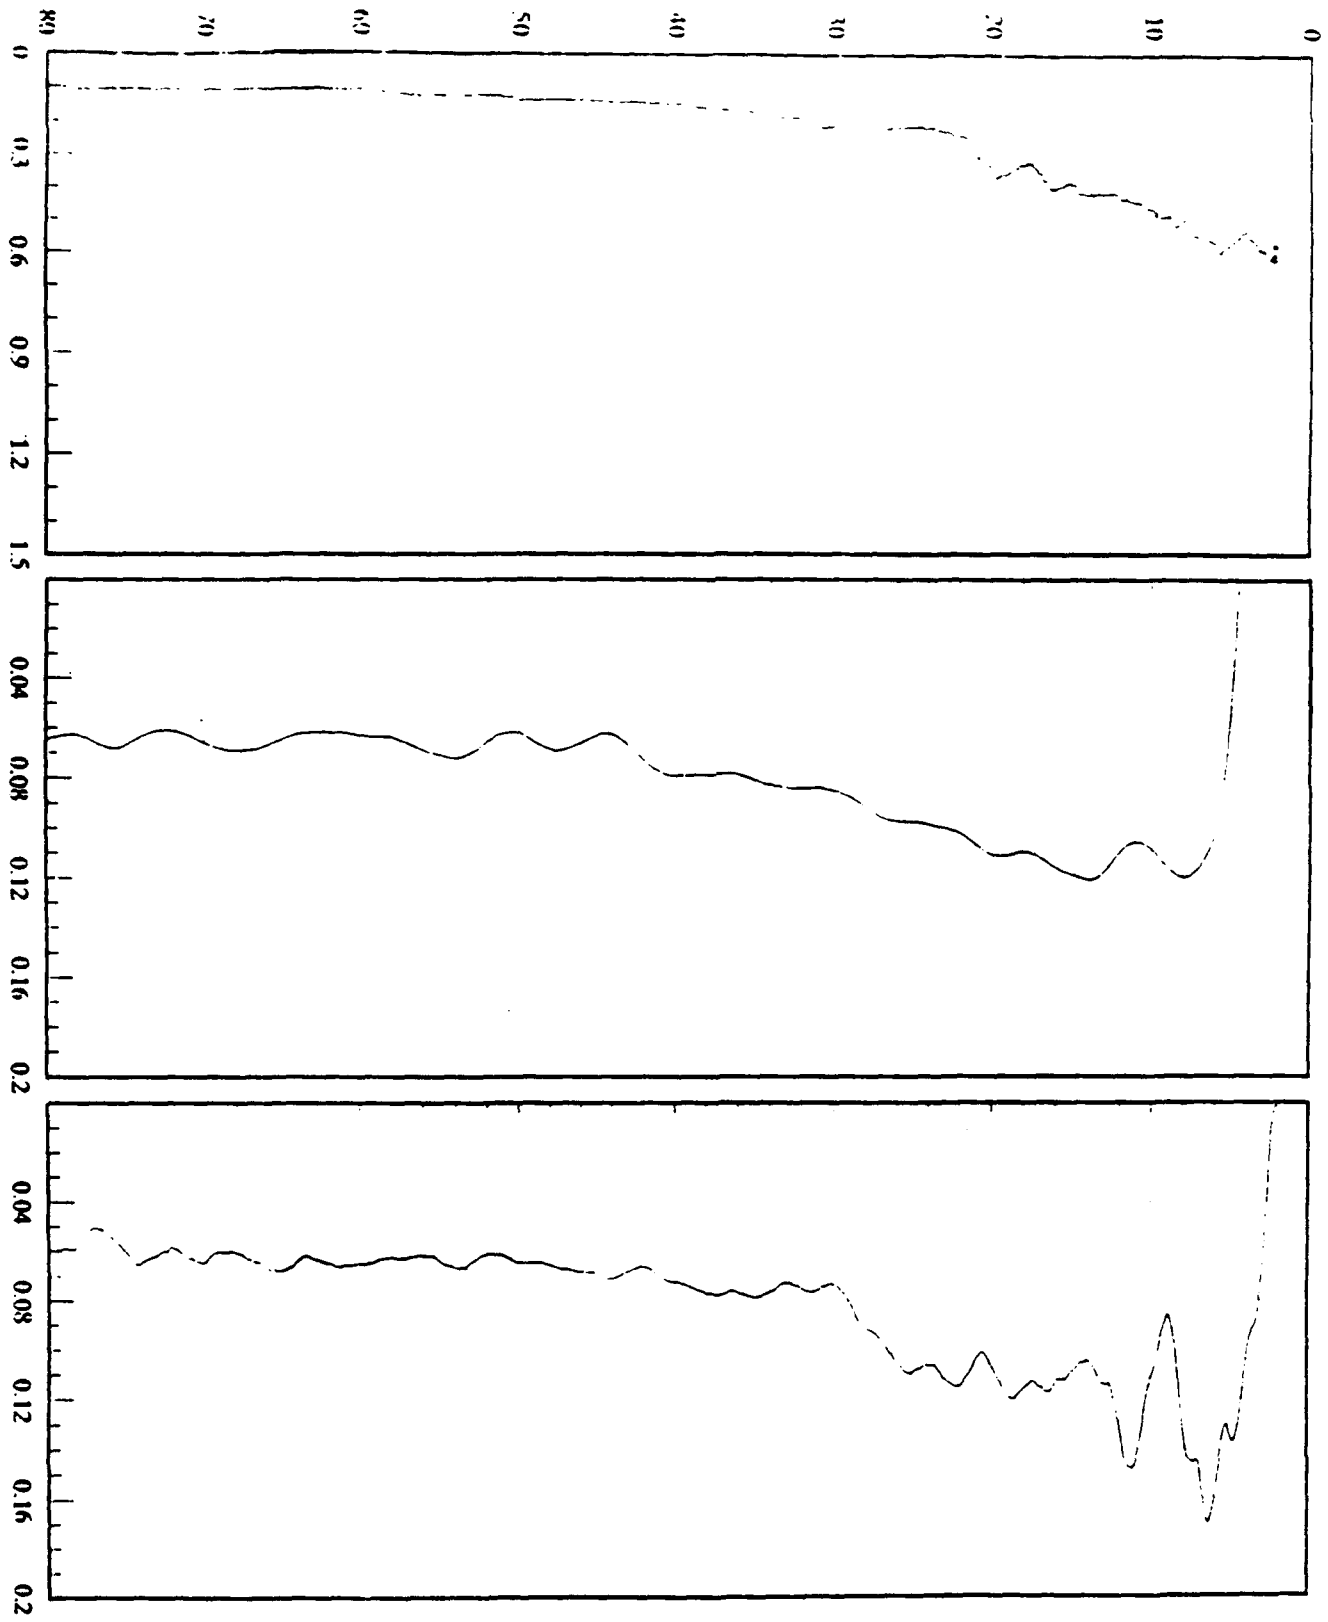
Graph 2

During subsequent and deeper analysis of the data from the first two tests, it appeared that in addition to the problems noted above, the system had a problem with being overly slow in responding to changes of illumination (See graphs 2 and 3). This slow response time manifested itself by 'smearing' optical features in the water column, making them appear to be much smaller in amplitude and much longer in duration. This problem becomes even more apparent when the K calculation is performed on the data. Another artifact that this slow response created was at very near surface, the probe was slow to respond to the sudden change in illumination that was experienced when the probe left the relative darkness of the launch tube and into the daylight. As can be seen in graph 2, the MER's data, even though it was started only at 5 meters or so, the XKT's data does not begin until approximately 8 meters. During this start up period, the apparent illumination is increasing, giving the appearance of a negative 'K' for the first ten meters.

In order to address this problem, several changes were made to the system. Electrical changes were made to the conditioning electronics in the probe, particularly in the logging amplifier, to speed up the response time of the probe. These changes resulted in a speed increase of approximately 2 to 1. Another change to address the near surface problem was the adoption of semi clear launch tubes that would allow the probe to see a much brighter environment during the stabilization period that occurs just prior to probe release.

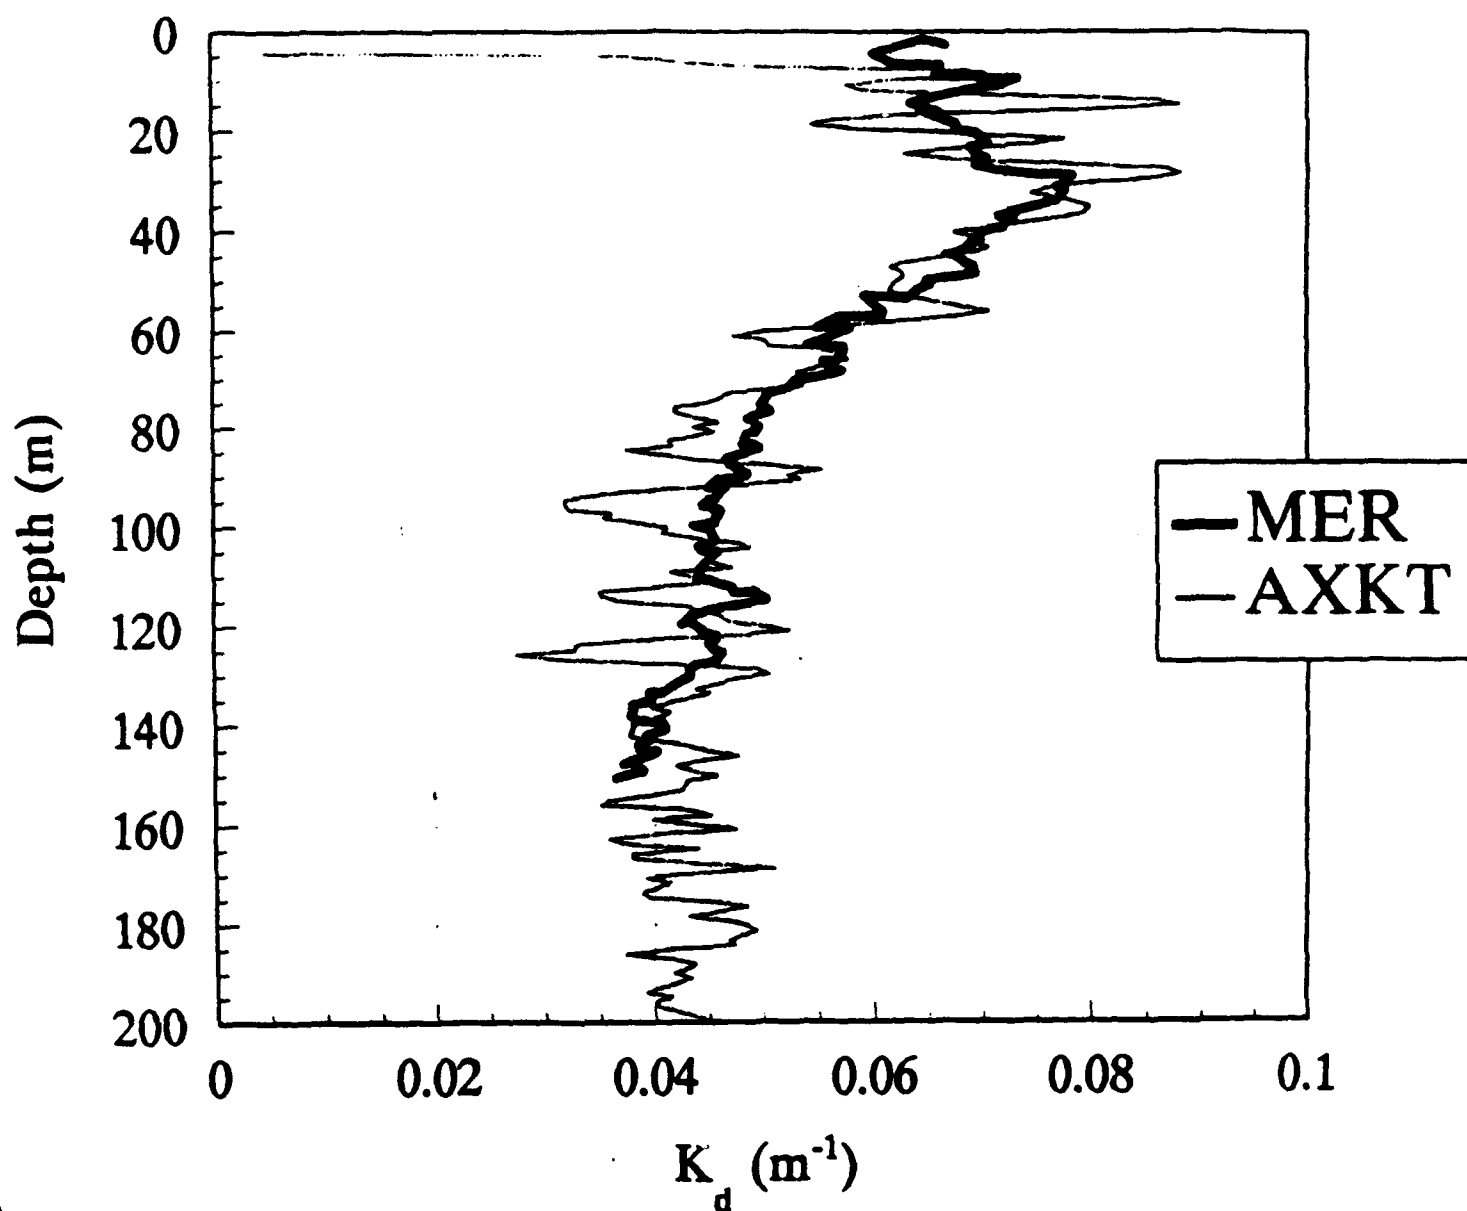
The effect of the electronic change to speed up the response of the probe looked encouraging. The comparison of data from the cable lowered MER and the few AXKTs that gave a good data set showed that the 'smearing' effect is considerably smaller with both instruments showing the same transition regions. Graph 4 shows a data set from the AXKT as compared to the MER optical data. The region from 20 to 60 meters, which has the greatest dynamics, indicates that the XKT keeps up with the MER for the average trend of data. The greater fluctuations of the XKT are possible due to the relatively rapid drop rate (relative to the MER), necessitating shorter averaging bins that allow for greater noise levels.

The translucent launch tube also showed promise. Again, due to the very few units that performed well, the slow response to the full ambient light level was greatly diminished, presumably due to the combined

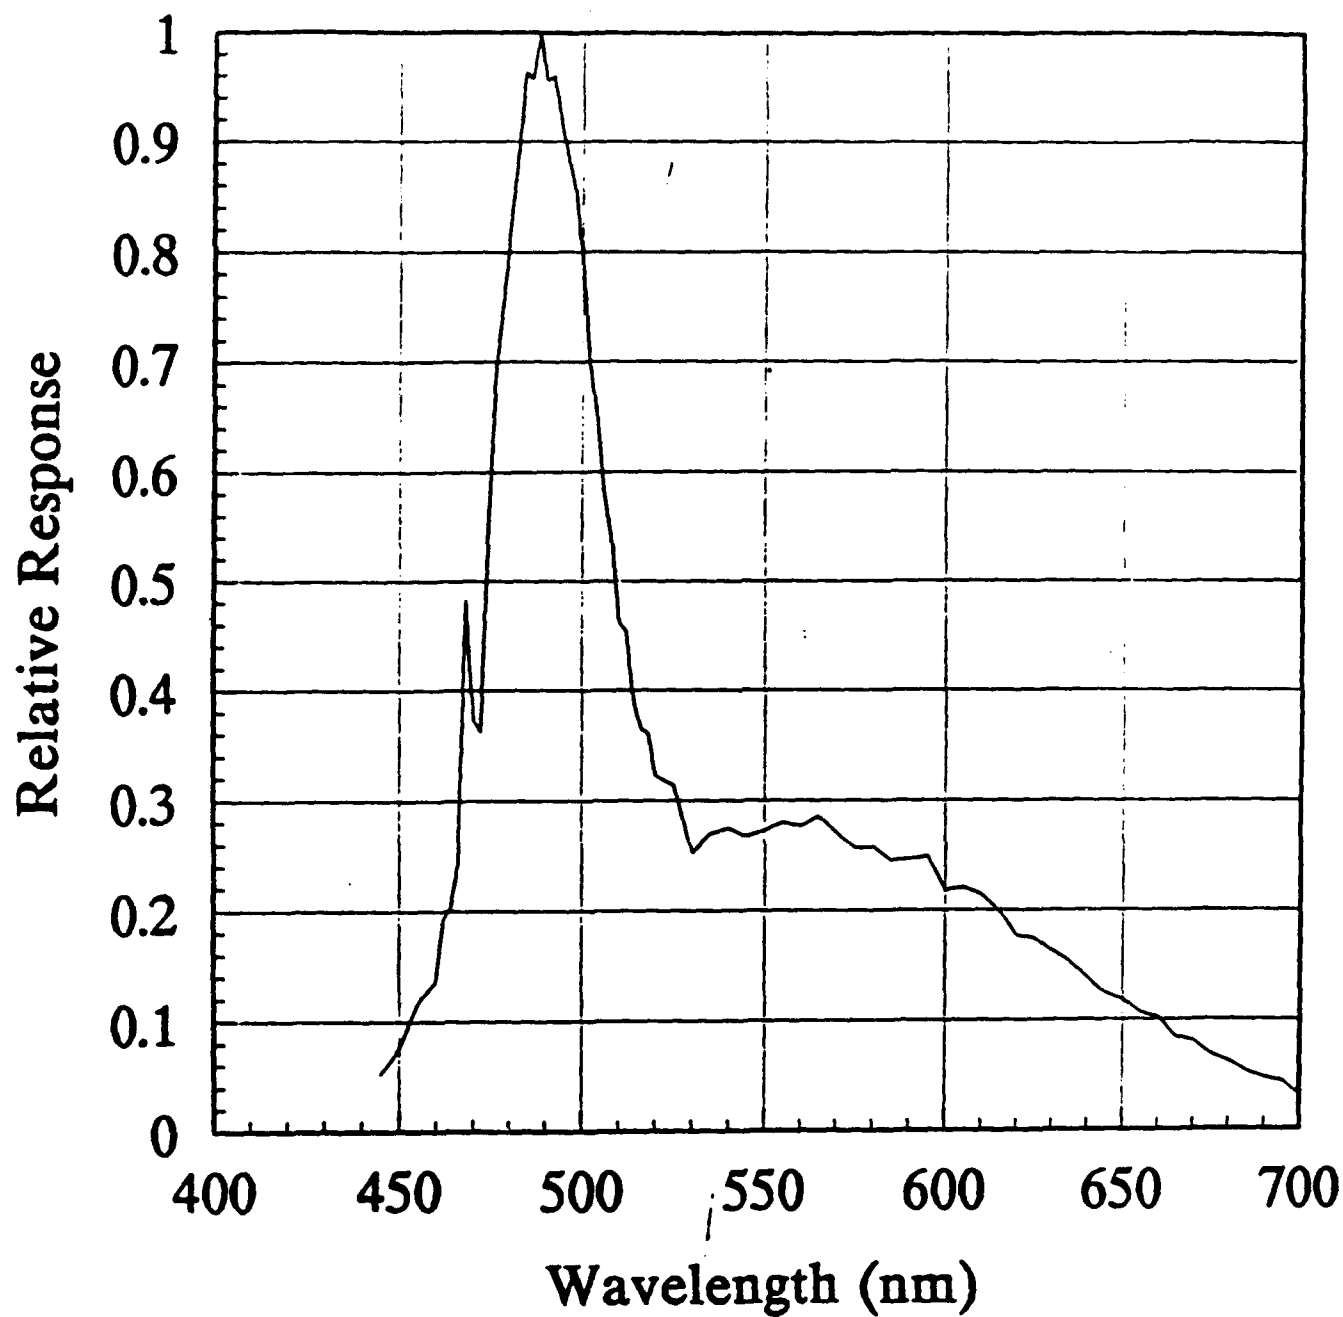
Graph 5

The probe was characterized for sensitivity versus wavelength (See graphs 5 and 6). In both cases the pass band appeared to be  $\pm 20$  nanometers (half power point). It was noted that at the longer wavelengths, ( $> 530$  nm), the transmission of optical energy remained above 10%. This red energy could introduce some error into the signal at the near surface due to biasing because of selective attenuation of the water column. Some work will be required to identify new filters to reduce this 'red shift'.

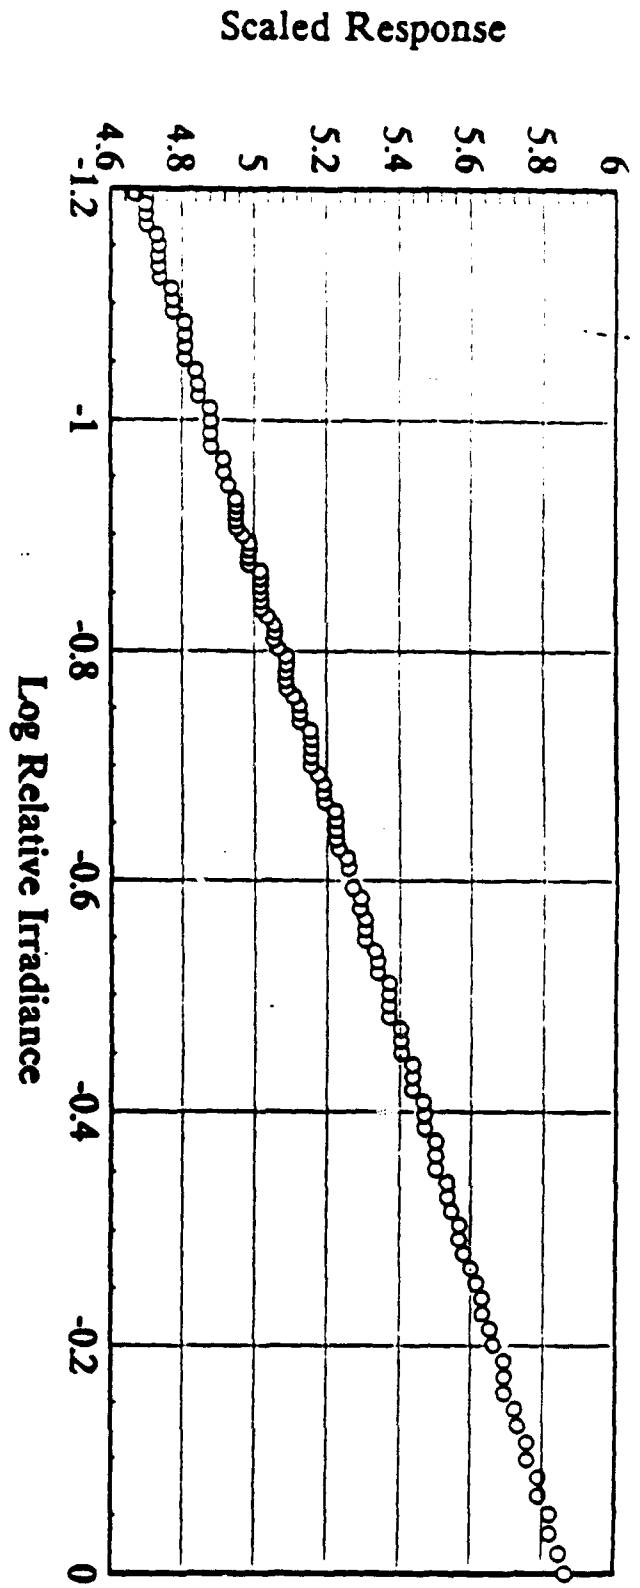
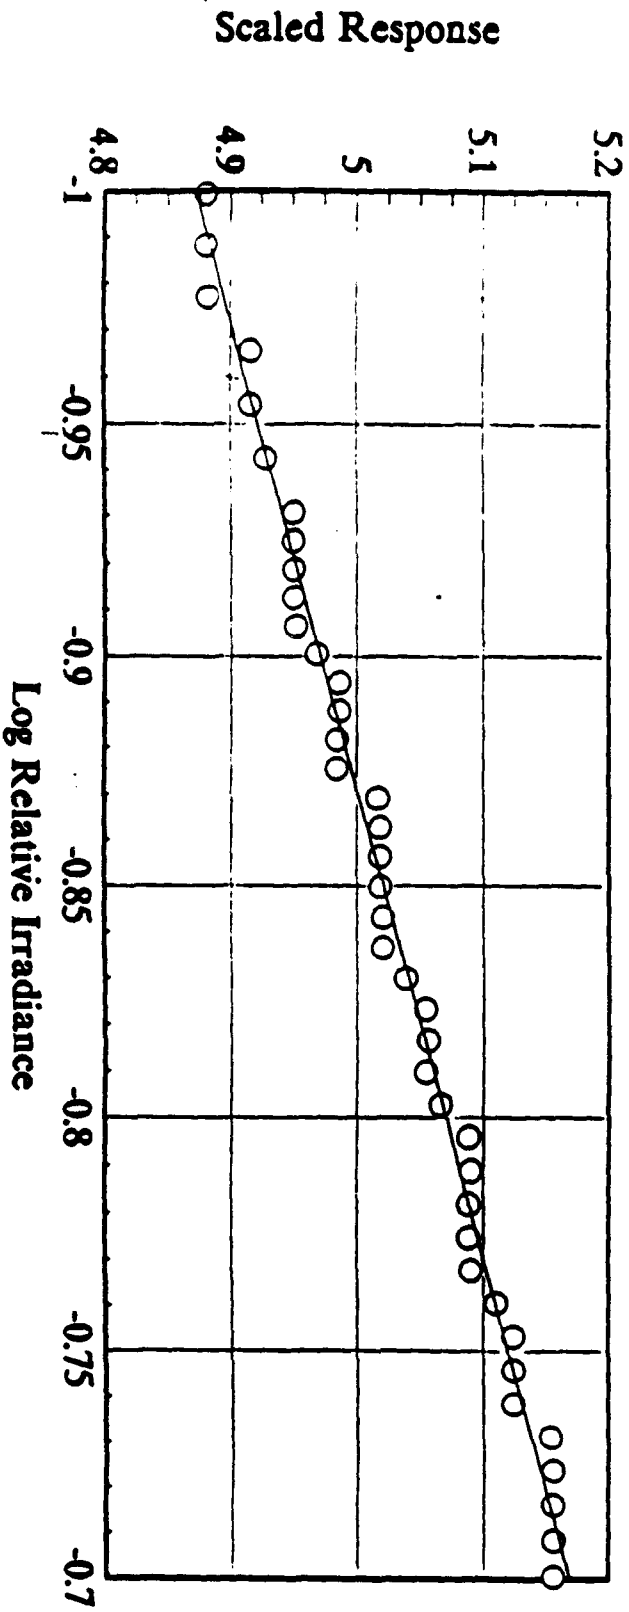
Graph 7

The 'steps' that were observed during the first two tests were verified in the laboratory with a controlled light source (Discussed later in this report). It appears that the probe electronics, particularly at the low light levels, would create an inadvertent feedback path that would lock the signal at a particular level. This level would remain until the outside illumination changed sufficiently to force the circuitry to 'step' to another level. At this point the correction to this problem is unknown. More laboratory analysis must be done to ascertain the exact conditions under which this problem appears.

During the tests for logarithmic conformity, the digitization or staircase effect was again noted. The manifestation of the effect is shown on graph 7 (Also graph 1 for a real time display). Again, further work will be required to determine the cause and the corrective action of this problem.

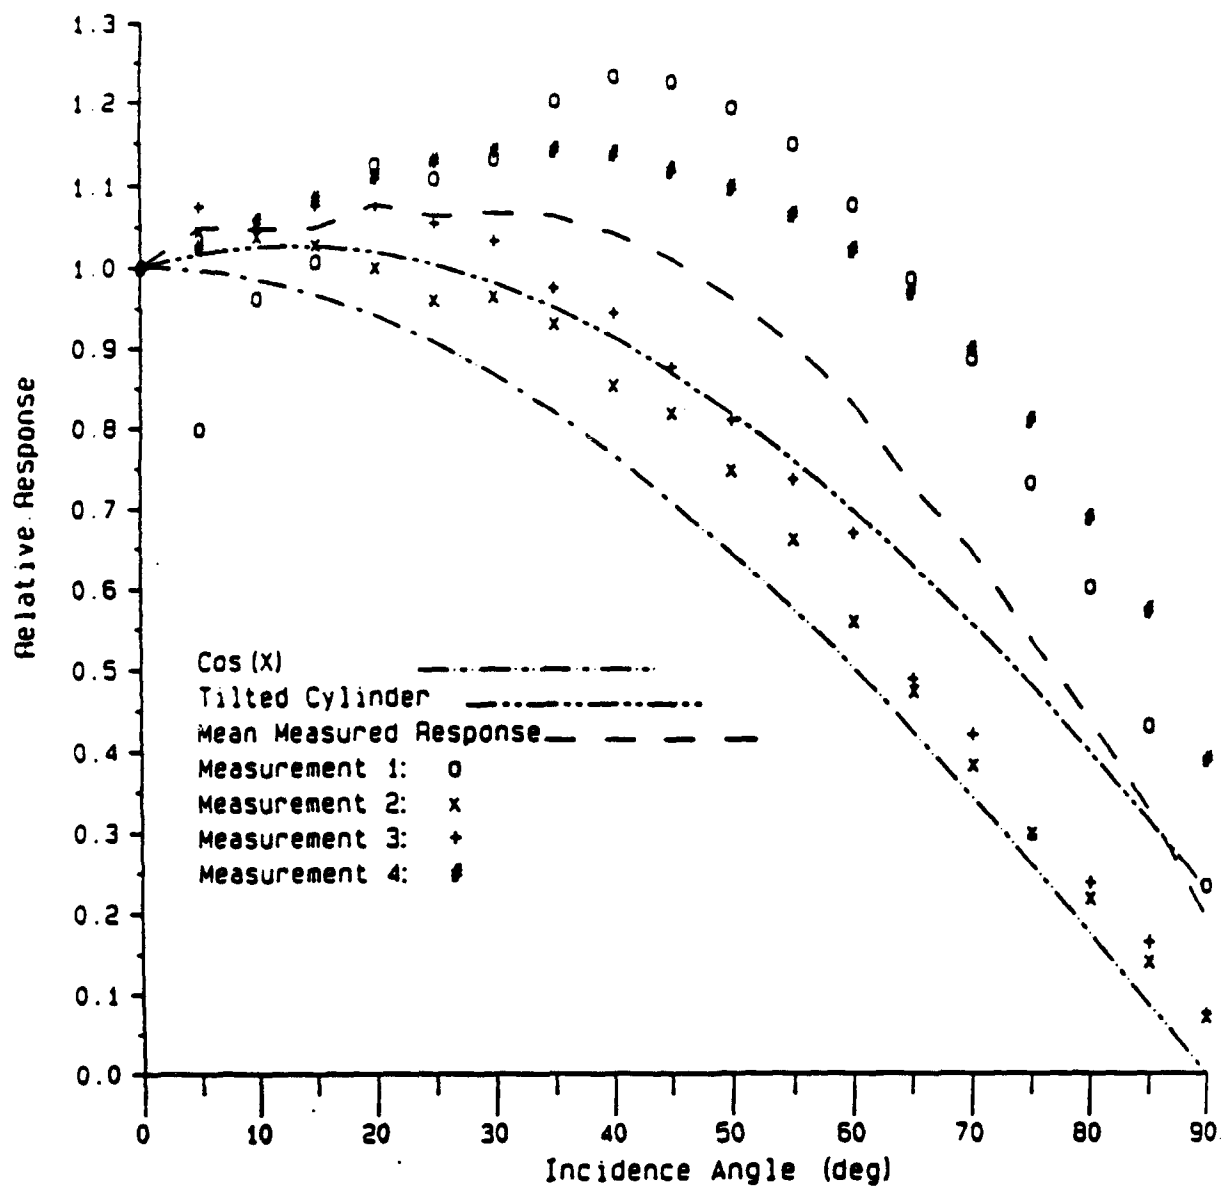
The directional response of the XKT detector was measured and compared to the ideal response of cosine weighted device. Graph 8 indicates the actual versus true cosine response of the detector assembly as a function of incident angle. As can be seen, the device has less than 10% error at the low ( $< 30$  degrees) angles, increasing with angle until at 45 degrees, the error increases to approximately 25%. It was noted that by recessing the actual detector within the housing, a much better correlation might be expected. It is also possible that reflections off the Delrin diffuser may be skewing the response with different angles. Testing needs to be done to determine the best geometry to produce the desired response.
